***NIST Workshop on Standards Development
for the Use of Fiber Reinforced Polymers for the
Rehabilitation of Concrete and Masonry Structures,
January 7-8, 1998, Tucson, Arizona.
Proceedings***

Typical Manufacturing Flaws in FRP Retrofit Applications

by Gary F. Hawkins, Eric Johnson and James Nokes
The Aerospace Corporation

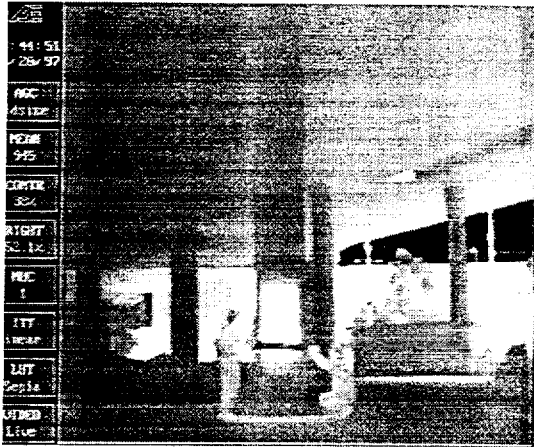
Figure 1. Infrared image of a column being heated.

Figure 1 is the image of a column taken from an infrared camera. The two technicians in the scene are slowly lowering a heat source. The heat source consists of 12 quartz lamps (500 W/lamp) mounted on a semicircular frame. The frame has wheels that hold the lamps 10 cm away from the column. In these experiments, the heat source was rolled down the column a distance of 2 meters in 30 seconds. The surface temperature of the composite over-wrap never exceeded 40 degrees centigrade. This temperature cannot cause damage to the composite, yet readily exposes the debonds. Notice in the figure how the area above the heat source is hotter (shown as a lighter shade) than the unexposed areas below the heat source. After the heating is complete, the heat source is moved out of the scene and after a few seconds an image, such as in figure 2, is displayed by the infrared camera. The hot areas which correspond to debonds are displayed as a lighter color; consequently, it is quite easy to detect the debonds from these images.
